Study and Analysis of Concrete Bridge - Case Study of Bridge 94R

Naser Morina

Abstract - This summary presents the inspection, assessment, and recommendations for the repair and strengthening of Bridge No. 94R on the national road N2, section Prishtina - Blacë. The objective is to identify optimal methods for repair and reinforcement, taking into account all bridge elements. If applicable, specific alternative methods suitable for this bridge may also be described. Where possible, the repair and strengthening works will be outlined as a set of modular actions, enabling the prioritization of tasks to address the immediate needs for improving the bridge. Priority will be given to aspects such as the main load-bearing beams, traffic safety, and durability. The proposed strategies for the repair and strengthening of Bridge No. 94R have been developed by comparing the bridge's current condition with the requirements outlined in the Eurocodes. This includes the assessment of structural elements and the evaluation of the load-bearing capacity of the bridge.

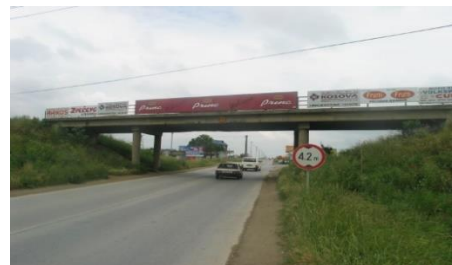
Description

Approaches:		Level 0 (good) to 3 (high severity)
Asphalt pavement	YES	1
Embankment	YES	1
Guard rail	NO

Abutments:		Level 0 (good) to 3 (high severity)
Type	Cap beams, reinforced concrete cast in situ	0
Joint with deck	NO	
Bearings and pedestal	NO visible	
Backwall	NO	
Wingwalls	NO

Pier:		Level 0 (good) to 3 (high severity)
Pier columns	YES, reinforced concrete cast in situ	0
Cap beam	YES. reinforced concrete cast in situ	0
Pedestals	NO visible	
Bearings	NO visible	
Superstructure:		Level 0 (good) to 3 (high severity)
Primary member	Cap beams	0
Deck structural	Reinforced concrete plate cast in situ	1
Joints	NO	
Deck elements:		Level 0 (good) to 3 (high severity)
Wearing surface	Asphalt	1
Sidewalk	YES, both sides 1,05	1
Guard rails	NO	
Parapets	YES	1
