Original Article

Evaluation of Bond Strength on Fiber Reinforced Concrete (FRC) with GFRP Rebars under Marine Environmental Conditions - An Experimental Investigation

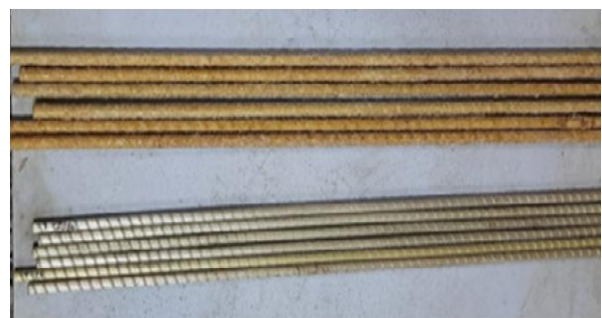
Fig. 1 GFRP rebars (Twisted and sand-coated)

one has a twisted surface, while the other is covered by sand. Each type of bar is pultruded, which is a method commonly applied in composite product manufacturing [6]. The main components of these reinforcing bars, therefore, include E-glass fibers and a vinyl ester resin. These two kinds of materials comprise the structural framework of the reinforcement system. The GFRP bars are curved shaped or twisted with a helical outer layer, which involves undulations on the exterior surface to increase the adhesion characteristics of the concrete. This design is based on prior studies showing surface roughness can adversely influence bond strength [7].

As for the sand-coated GFRP bars, the bars have to be treated by applying coarse silica particles on the surface of the bars, a process that complies with the guidelines in the ACI440. 3-03 (2003) for enhancing bar concrete interfaces [8]. Images of these GFRP bars are shown in Figure 1, while Table 1 presents a summary of the mechanical characteristics of GFRP bars. This data presentation is consistent with conventions used in the materials science literature in terms of the clarity of the characteristics presented here [9].

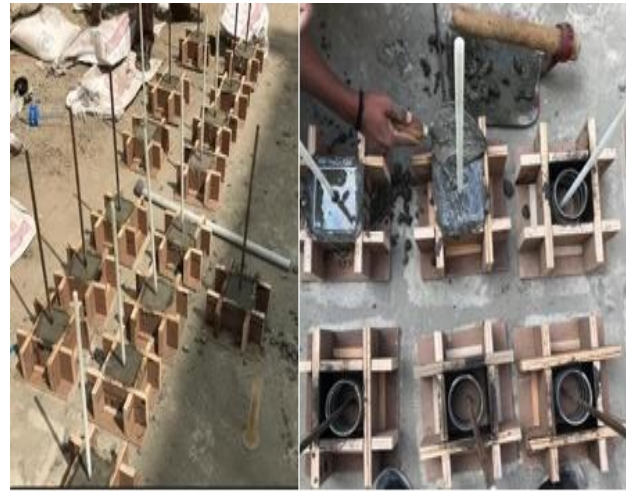
Specimens during casting

For the purpose of casting the specimens, the concrete was prepared for mixing with the help of a laboratory drum mixer. Altogether, 32 cubes with varying GFRP rebars and 12 control cube specimens of 100 x 100 x 100 mm were prepared for crushing test. The specimens were compacted in two layers, or three layers, with an internal vibrator. All the specimens mentioned above were allowed to be set at room temperature for 24 hours. After demoulding, they were treated in a tank for twenty-four hours at room temperature, followed by a curing period of twenty-eight days.

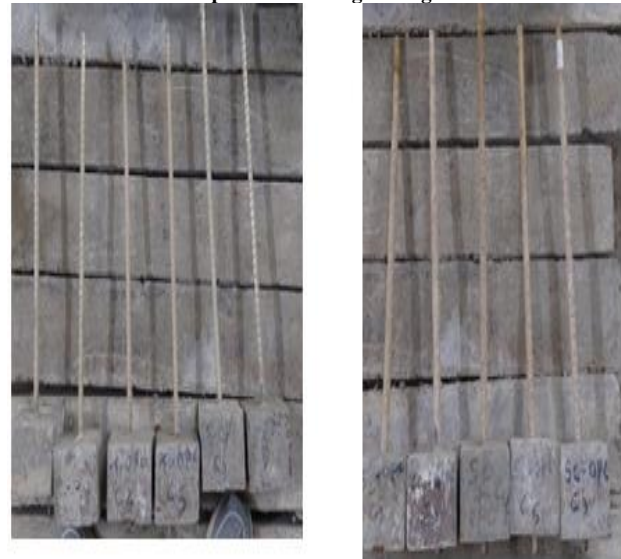
Specimens after 180 Days of exposure to chlorine
GFRP rebar twisted, GFRP rebars and coated
Fig. 2 Pullout specimen details

As per ASTM D7913 (ASTM International 2014) [11], the authors performed pullout tests on as many as 36 specimens. Characteristic features of both ends of the GFRP rebar specimens were taken into account during preparation. On the loaded end, where force was applied, a 300 mm long steel pipe enveloped the rebar to prevent it from being damaged by grips since it has negligible transverse load-bearing capacity. The free end of the specimen was placed vertically into an acrylic resin concrete cube with a dimension of 100×100×100 mm. Of the 100 mm bar length embedded in concrete, only 50 mm, which is four times the diameter of the bar, was meant to have a bond with the concrete.

The other 50 mm within the cube was also treated to not bond with the core, as shown in Figure 2 (JSCE-E 539, 1996) [12]. That arrangement made it possible to have a controlled bonding channel that would provide accurate test results. Sample preparation consisted in pouring the samples into individual molds made from plywood, as indicated in Figure 2 left. It has been considered important to place fresh concrete in two layers and compact them using a vibrator to enhance the material's consolidation.

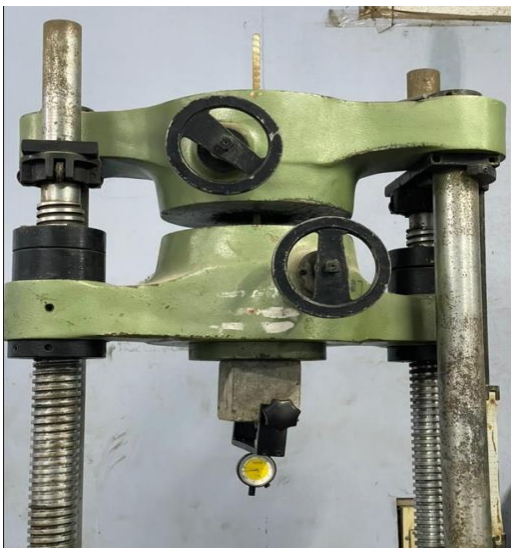
Fig. 3 Pullout test setup

Cube specimens were subjected to pullout load testing, as shown in figure 3.

In the experiment, the test arrangement involved a specially constructed test configuration for cubic specimens in which the bar’s long end rested on a rigid reference plane and anchored by rounded end wedges. A 2,000 kN universal testing machine evaluated the pullout behaviors of GFRP bars, both with and without fiber addition. Displacement measurements were taken at the loaded and free ends of the embedded rebar to analyze bond slip, following industry guidelines. Concurrent compressive strength tests on cylindrical specimens provided context for the concrete’s properties. This comprehensive approach allowed for a detailed analysis of bond behavior between GFRP rebars and concrete under various conditions, capturing the full range of bond-slip characteristics and revealing insights into how fiber addition and different GFRP rebar types affect bonding in concrete structures. The inclusion of compressive strength data enriched the overall understanding of material performance.

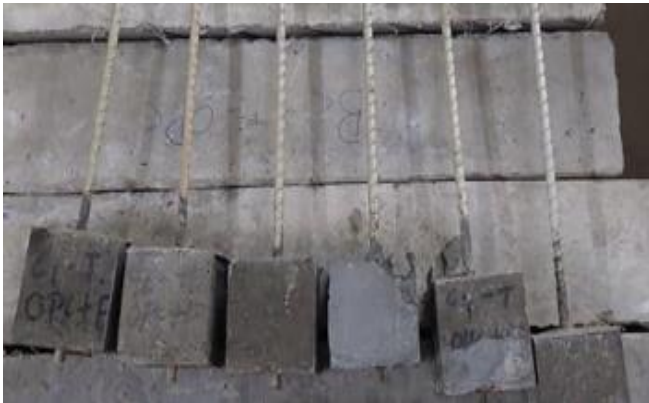
Fig. 4 Plain concrete specimens with GFRP rebar exposed to chlorine

The environmental conditioning process resulted in noticeable changes to the specimens. Surface deterioration was evident across most samples, with the concrete exhibiting signs of scaling. More significant damage was observed in specific areas, particularly at the corners of the specimens. The degradation was severe in some cases, leading to substantial concrete fragmentation. These effects are visually documented in the accompanying image.

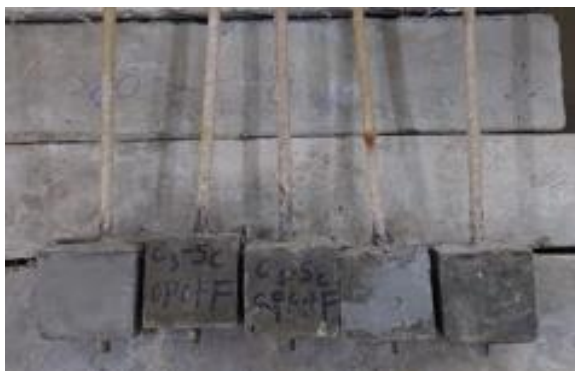
Fig. 5 FRC specimens with GFRP rebar exposed to chlorine

The environmental exposure primarily affected the outer layers of the samples. As the concrete surface eroded, the underlying fibers became visible. Despite this surface deterioration, all Fiber Reinforced Concrete (FRC) specimens maintained their structural integrity, as depicted in the accompanying image. Compared to their non-reinforced counterparts, the FRC samples demonstrated superior resistance to environmental degradation, showcasing the protective benefits of fiber reinforcement against harsh conditions.

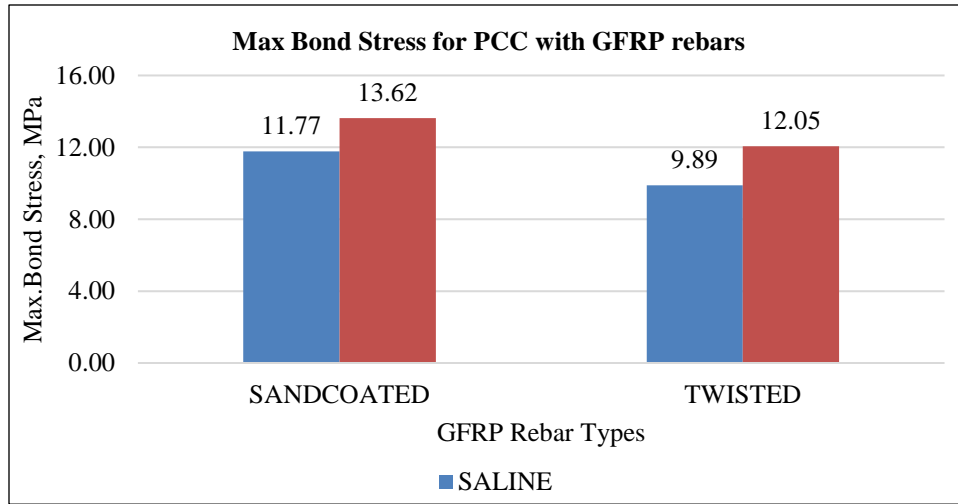
Fig. 6 Bond Stress for PCC Specimens with GFRP rebar exposed to chlorine/conventional conditions

From Table 8, It is found that Sand-coated GFRP rebar reached maximum bond stress of 11.77 MPa under Marine exposure and 13.62 MPa under Conventional exposure conditions, whereas Twisted GFRP rebar attained maximum bond stress values of 9.89 MPa and 12.05 MPa after Marine and Conventional conditions after 180 days of exposure at 45 deg C temperature conditions. The maximum bond stress for both GFRP rebars was more than the average bond stress of 8.58 MPa as per ACI 440.1R -15 requirements. Reduction in

bond stress values was observed at 13.54% for sand-coated GFRP rebars and 17.91% for GFRP twisted rebars, respectively, when compared to unaged specimens. Figure 6

shows the bond stress for both sand-coated and twisted GFRP rebars with PCC under chlorine and conventional exposure conditions.

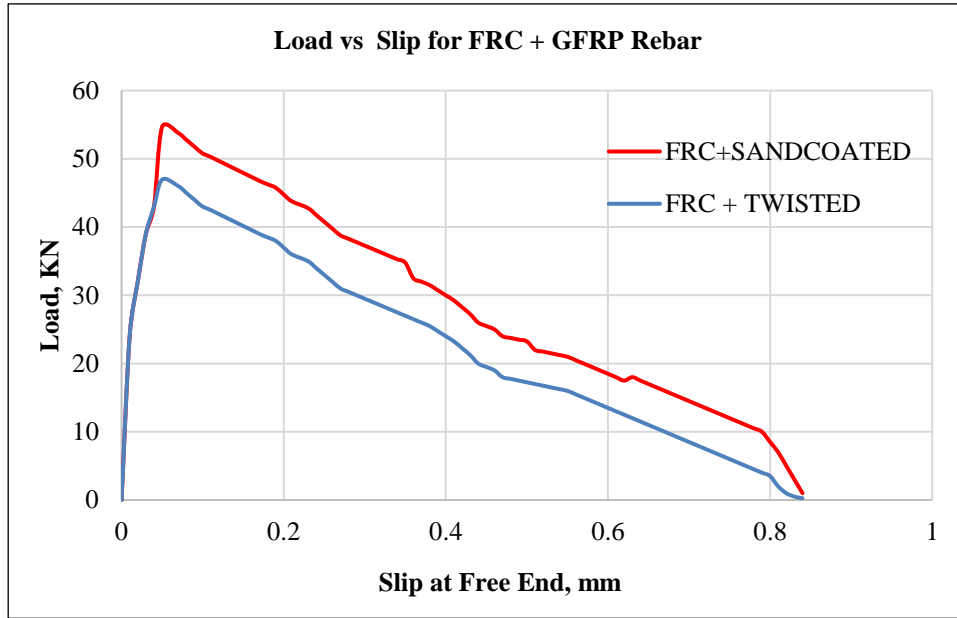
Fig. 10 Load Vs Slip for FRC specimens with GFRP rebar exposed to marine conditions

The specimens tested under standard conditions had relatively similar test results, while the ones that were exposed to environmental conditioning had higher variability of the test results, likely because of the random nature of the degradation process. Samples of plain concrete as well as DC concrete were also submitted to interface bond strength testing, and it was ascertained that concrete which was more deteriorated resulted in lower bond strength and plain concrete samples which displayed severe deterioration registered the lowest values of bonding strength.

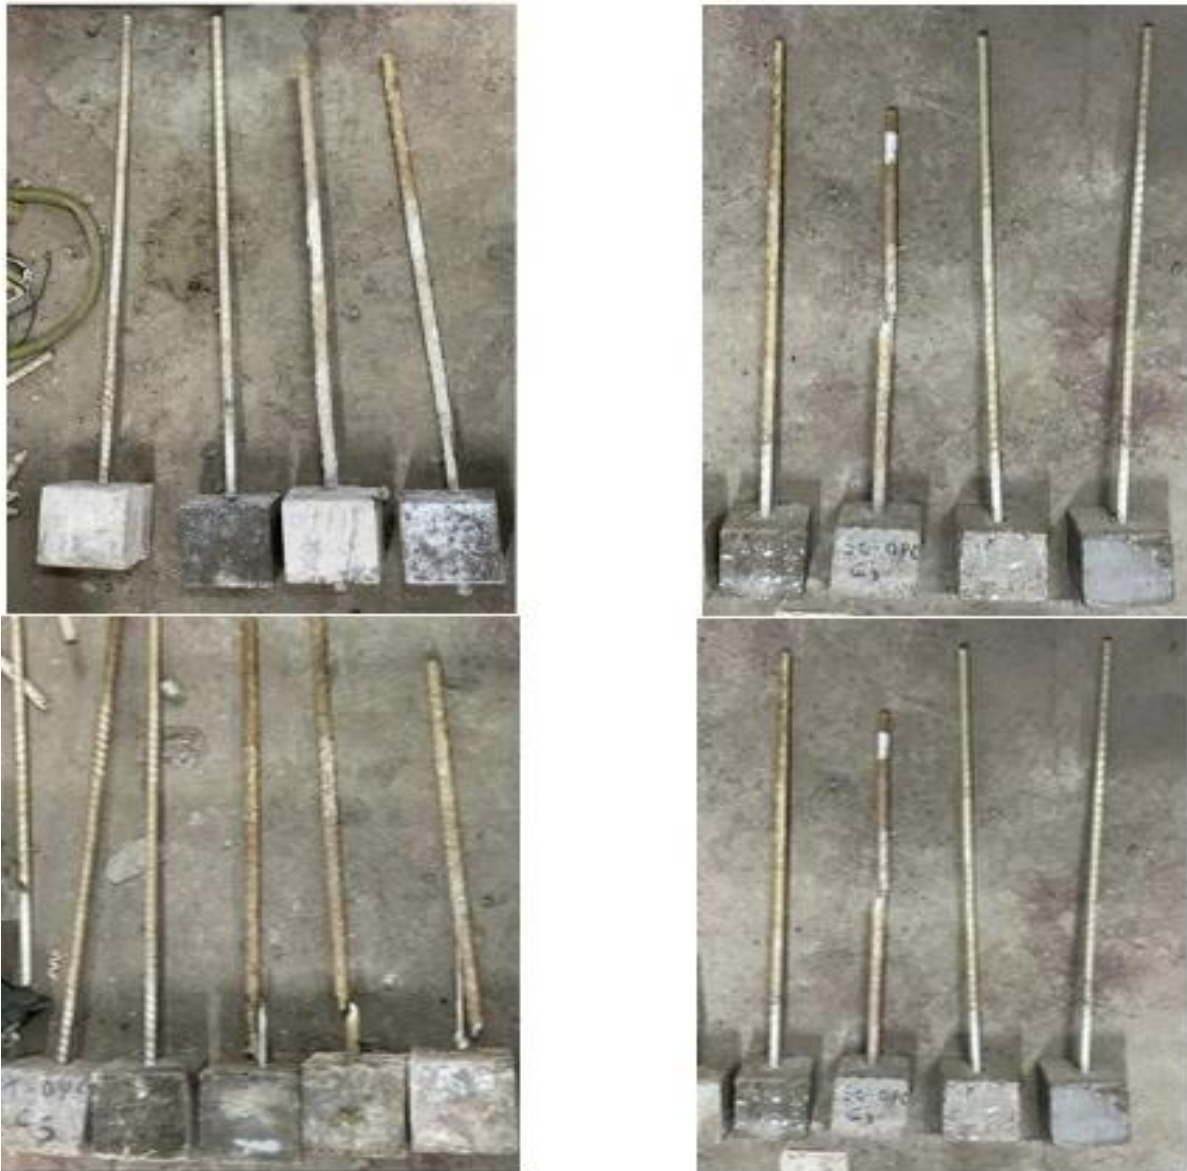
Fig. 12 Failures modes of GFRP (Sand-coated/Twisted) rebars@ direct pull out test after 180 days of exposure under marine/conventional exposure conditions

observed in samples that were not exposed to moisture. Nevertheless, significant shifts in failure modes were identified, particularly for the Sand-coated and twisted GFRP rebar specimens, which underwent environmental conditioning. These changes in failure characteristics imply that these specific GFRP rebar forms could be more vulnerable to variations in bond behavior from the weathering procedures that they undergo.

Twisted GFRP did not rise to the challenge in the reinforcement pullout test, while sand-coated rebar failed in rebar elongation or splitting of the rebar. The failure modes of the GFRP rebar are discussed below and presented in Figure 12.
